MERUS
WEBN2
Flüssigkeitsbehandlung

MERUS
DREDGING

DREDGING

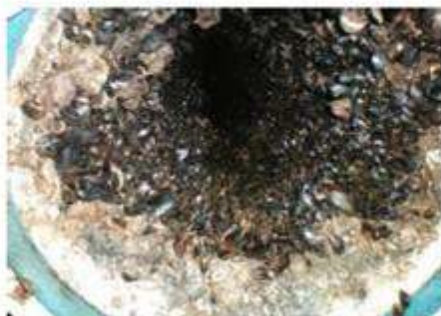
Due to the lay out, the 25 meter long suction line from the cross over to the engine room was full of mussels almost every year. We have tried (and still are..) using various chemicals and cathodic protection. But no significant improvement as result. In the best case the fouling with mussels was extended over 2 years in stead of 1 year. At high cost of chemical dosing and a lot of problems with coolingwaterflow.

In November 2013 we became aware of the MERUS ring concept, we decided to install such a ring on the sea water inlet before the sea water filter. After one year our preliminary conclusion is that it has a positive effect on the sea growth in the sea water suction line towards the engine room. Where we before had a drop in suction pressure before the sea coolingwater pumps, we now still have a positive suction pressure, even with a big Drencher pump working. Below are some pictures to prove the above mentioned. Left is the typical condition we find the pipe in after one or two years, right was the condition last November 2014.

Typical at end of season

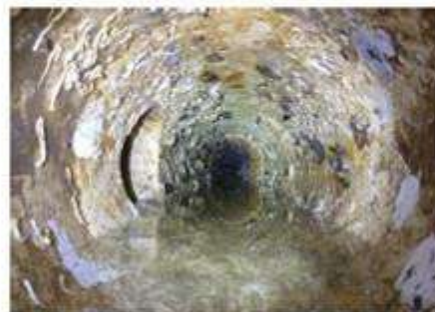
November 2014 > 1 year with ring

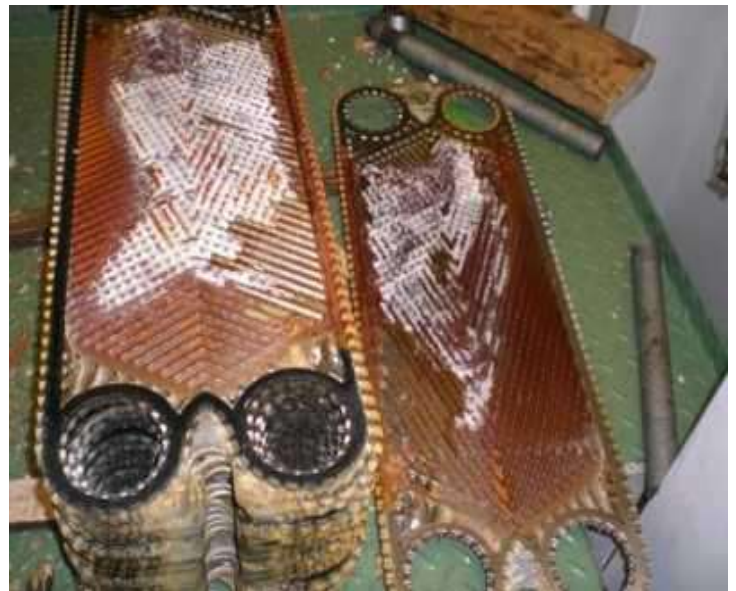
All vessels that travel by sea, not only along the coast, must produce drinking water or fresh water from the sea on board. In this case, there is a fresh water generator on board the Alfa Lava, whose production capacity is 25 m³ per day. Despite cleaning the generator with chemicals, production capacity has been reduced over time. Once the volume produced reached the minimum amount of water needed on board, the fresh water generator had to be dismantled. Each tile needs to be manually cleaned with chemical cleaners before it can be put back to work. In addition to all seals that need to be replaced during the cleaning process.

The first picture shows what the plates in the generator look like after several months of work.

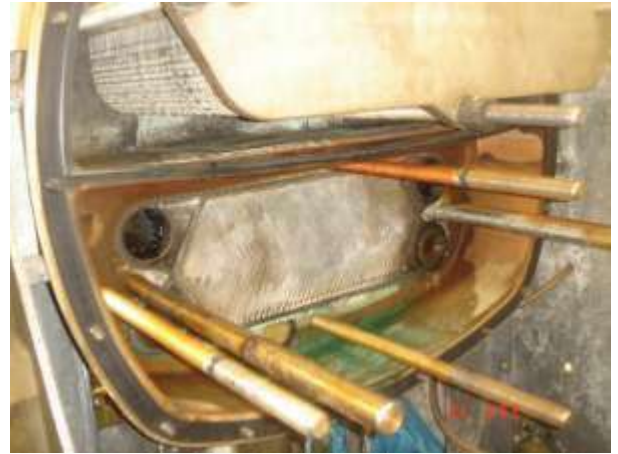
The figure shows that all plates are clean, just as assumed from the monitoring data.

The only dirt is brown film that can be easily removed with a cloth.

From Hapag Lloyd we received an email from the fleet manager stating: " After 8 months since the last cleaning the condition of the evaporator is very good. All plates are clean and there are no residues on the surface of the evaporator or condenser. "

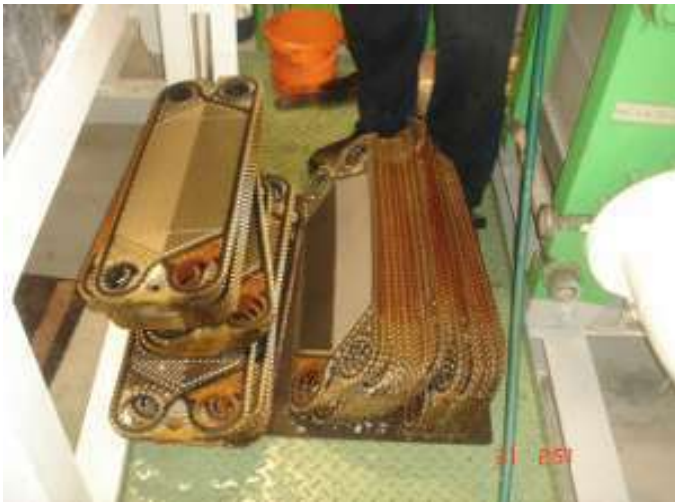
Execution monitoring

The system automatically collects data on the production volume and pressure in the generator. Therefore, it is very easy to follow the development from the inside. Under normal conditions, a gradual drop in pressure is expected as described above. After installing the Merus ring, we recorded an amazing increase in production volume. After increasing the value stabilized at nominal capacity so far.

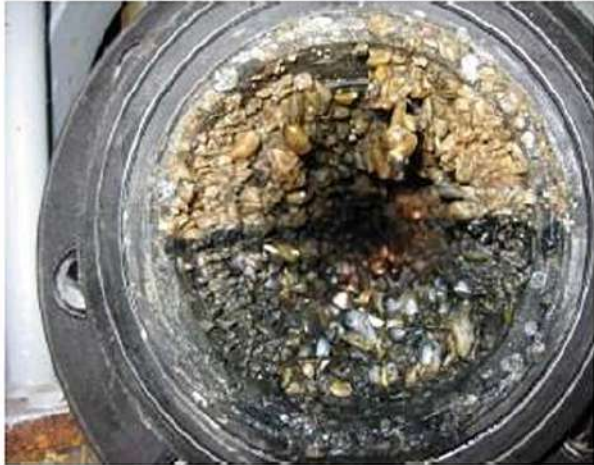
All pictures below are the same cross-over. As you can see the biofouling has reduced in the cross-over.

Without Merus-ring, after 1 year.

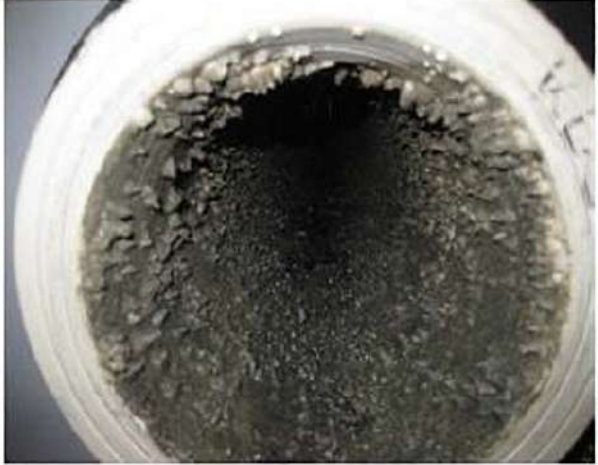
With Merus-ring, after 1 year.

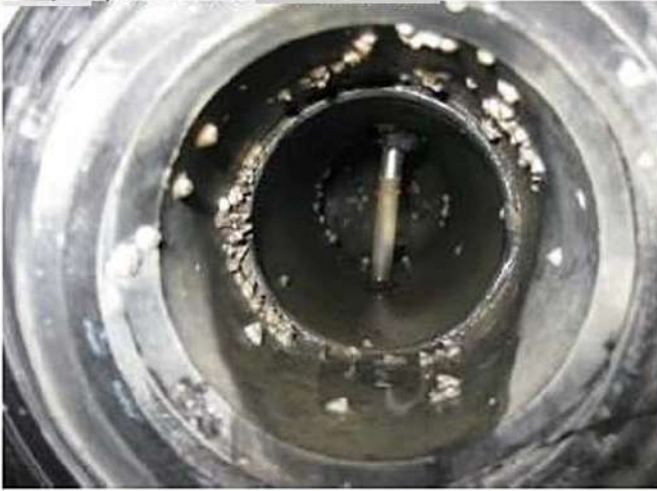
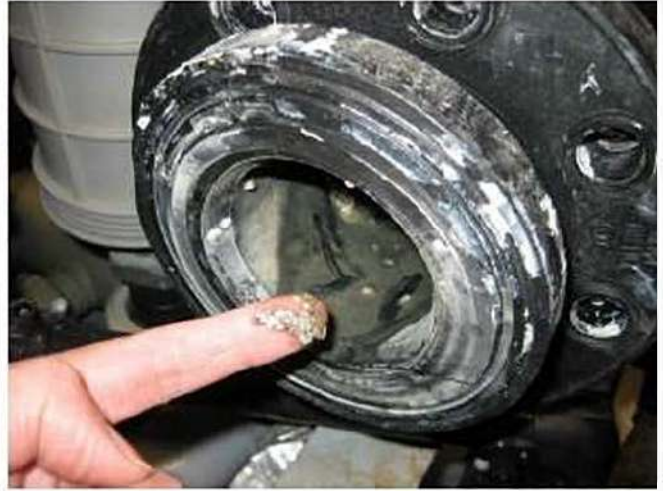
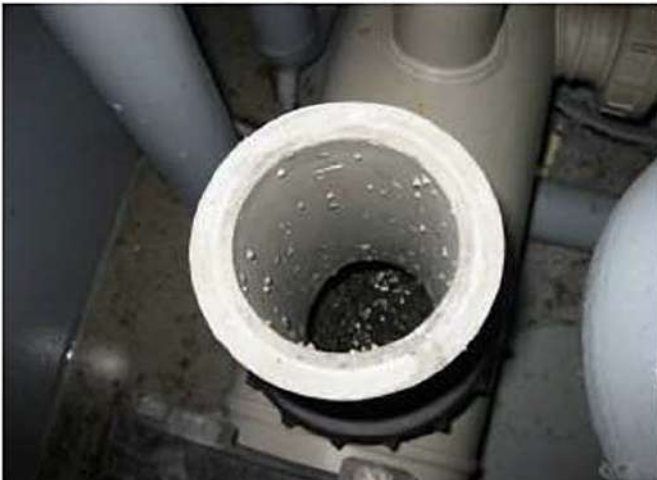
Cross-Overs

The outgoing pipeline of the cross-over connected to other applications are also clean and almost biofouling free, as you can see on the pictures.

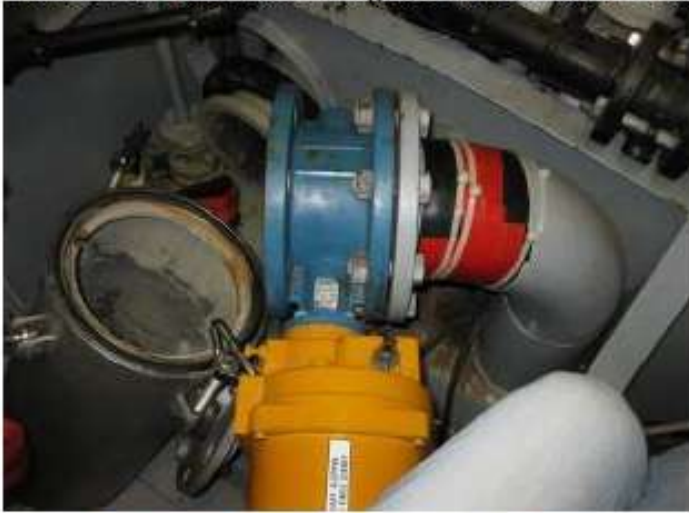
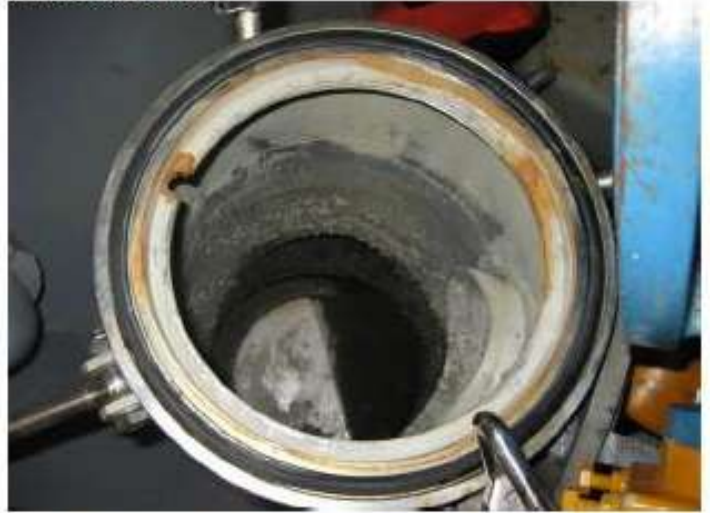
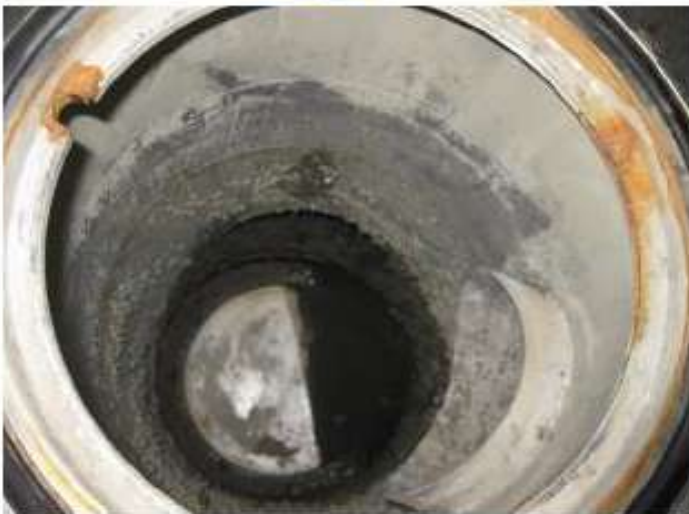
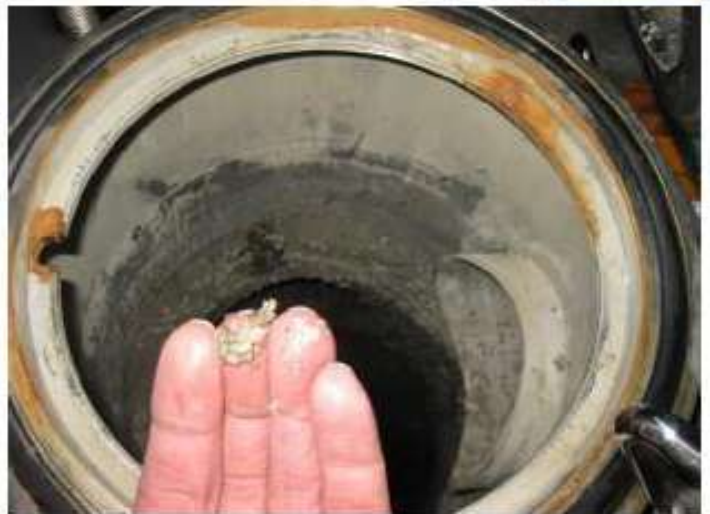
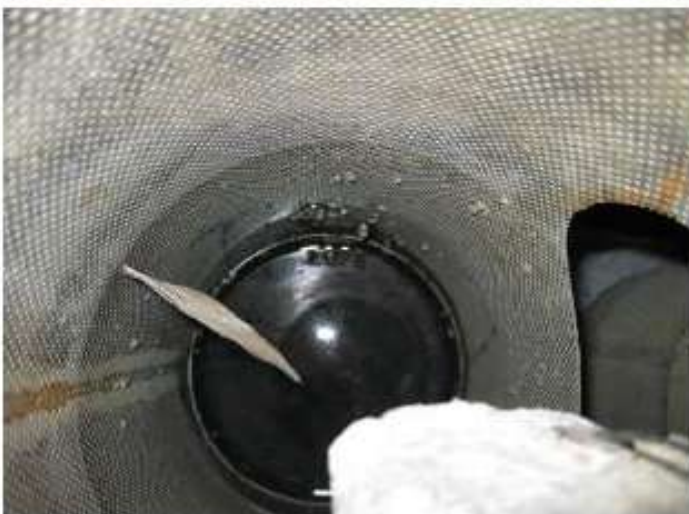
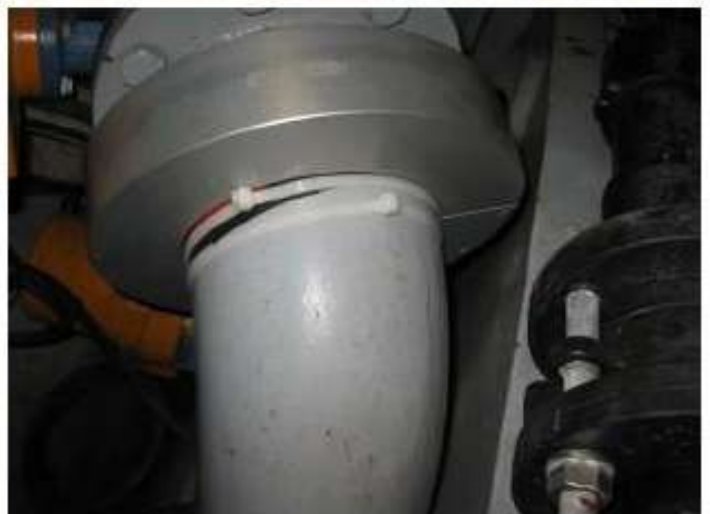
Filter Chamber and Seaweed Chamber

You can see that the marine growth is reduced and has a softer structure.

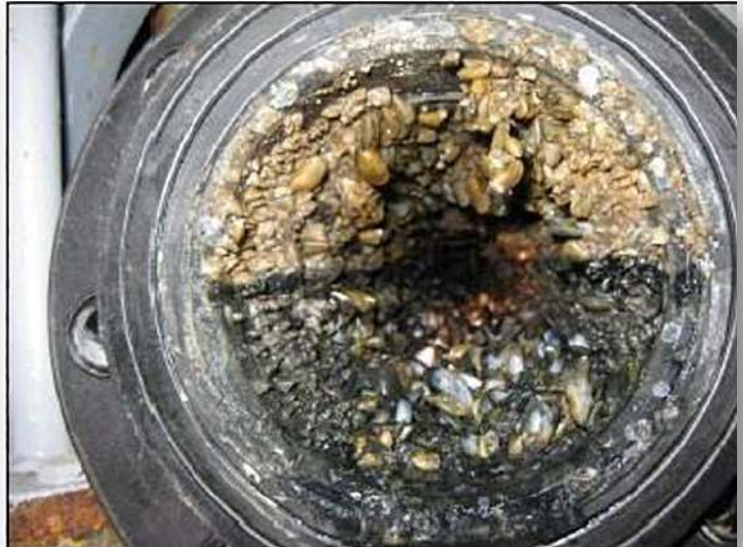
In the picture you can see sea growth built up in less than one year !

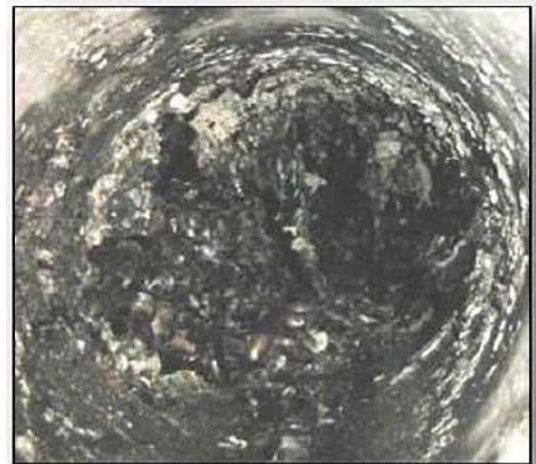
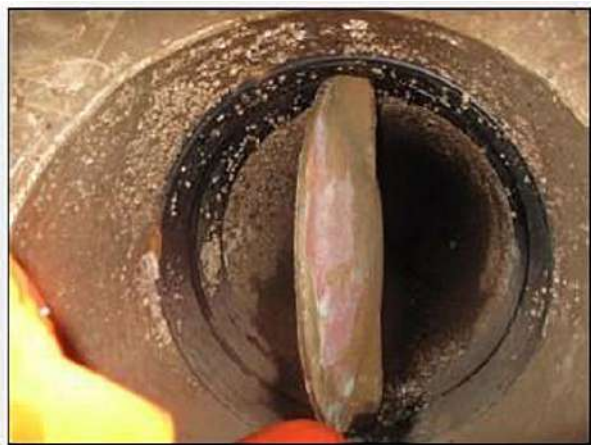
A seawater pipe on a dredger after 2 years sailing in warm waters with the Merus Technology.

Additionally to less seagrowth in general, it was reported that the remaining barnacles were much easier to clean.
